## MEMORANDUM

Date: October 17, 2006  
Project No: 054067.01

Subject: Humpback Creek Hydroelectric Facility Inspection and Assessment

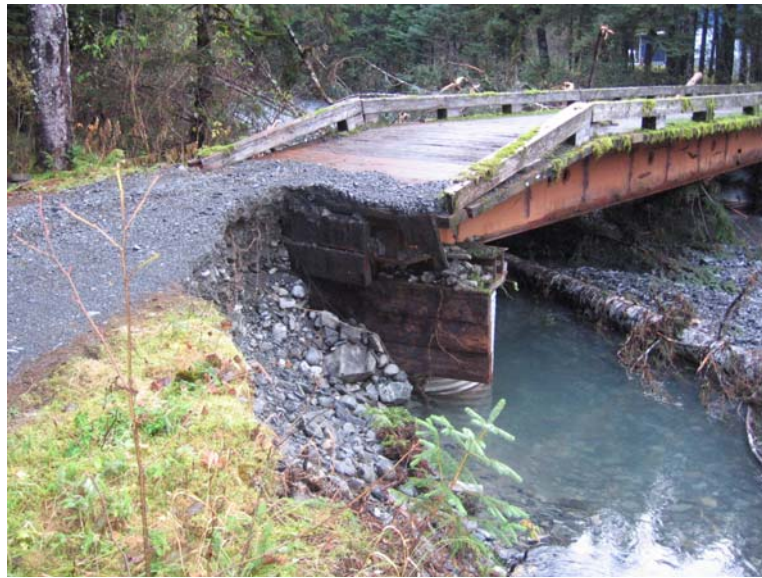
**Photograph No. 1**

The existing bridge has had the right abutment fill scoured (see Photo 1). In addition approximately 12-inches of scour has occurred at the center bridge support (see Photo3) and significant log debris is present on the upstream side of the bridge (See Photo 2).

**Right abutment scour.**

Work Required: The log debris should be removed as soon as possible to prevent flood damage from any additional storm events that occur. Gravel fill material should be placed adjacent to the bridge abutment and additional riprap armor may be needed upstream and downstream from the bridge. Once the timber is removed additional work may be discovered. The center support, on the upstream side, should be checked to determine if any additional scour occurred that could warrant placement of additional fill or riprap at this location.

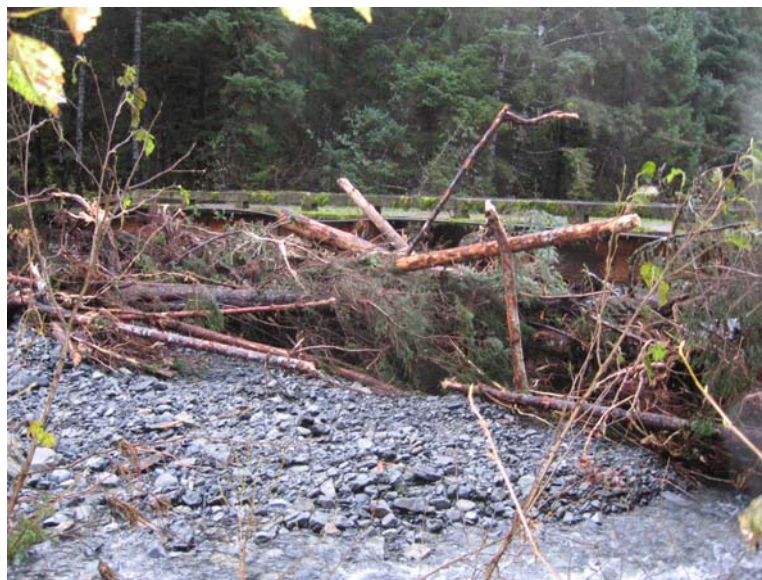
**Photograph No. 2**

**Upstream edge of bridge with log jam.**

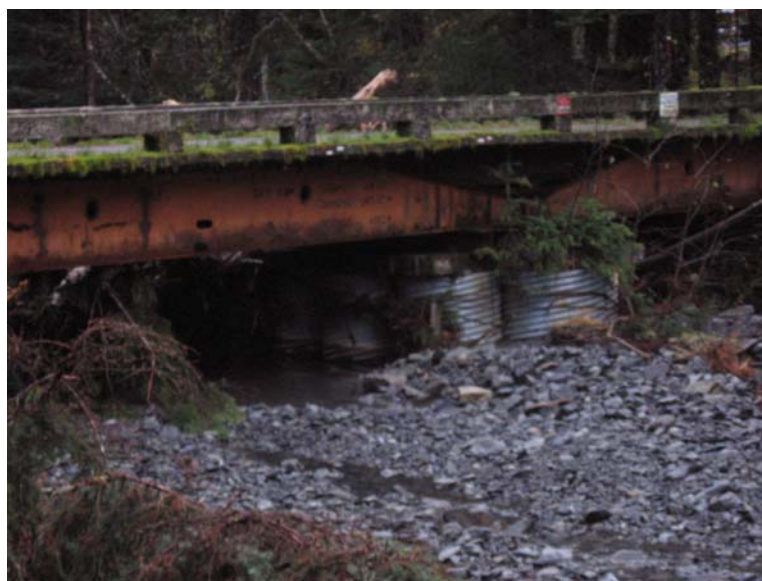
**Photograph No. 3**

**Approximately 12-inches of scour at center span support. Possibly more may be present at upstream end but could not be inspected.**

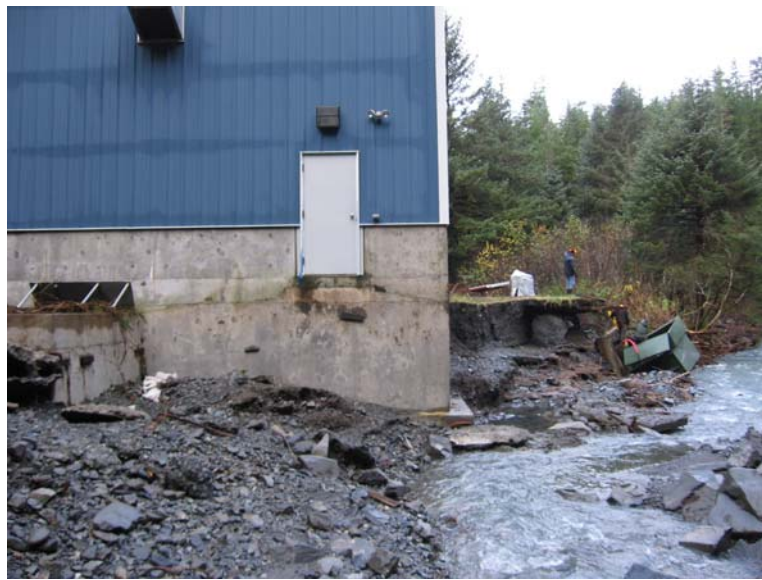
**Photograph No. 4**

One transformer was transported approximately 1/2-mile downstream and the other had the bank undercut and is resting in the stream (see Photo 4). Both will need to be removed from the creek.

Significant scour, up to 10 feet deep and 20 to 30 feet in areal extent has occurred adjacent to the building as shown in Photo 5. Armor rock along the stream at this location was approximately 2 feet in diameter. Existing gravel may need to be excavated and placed closer to the building and new riprap of larger dimension installed to provide more suitable protection from flood events. The armor should be approximately a D50 size of 3.5 feet; a D100 size of approximately 5.5 to 6 feet. The armor thickness should be approximately 1.5 times the maximum size. Armor should be placed in a manner suitable for protection of the building foundation to minimize potential for future scour.

Approximately 10 feet of scour occurred along with loss of riprap and gravel at power plant. Note transformer in river. Second transformer approximately 1/2-mile downstream.

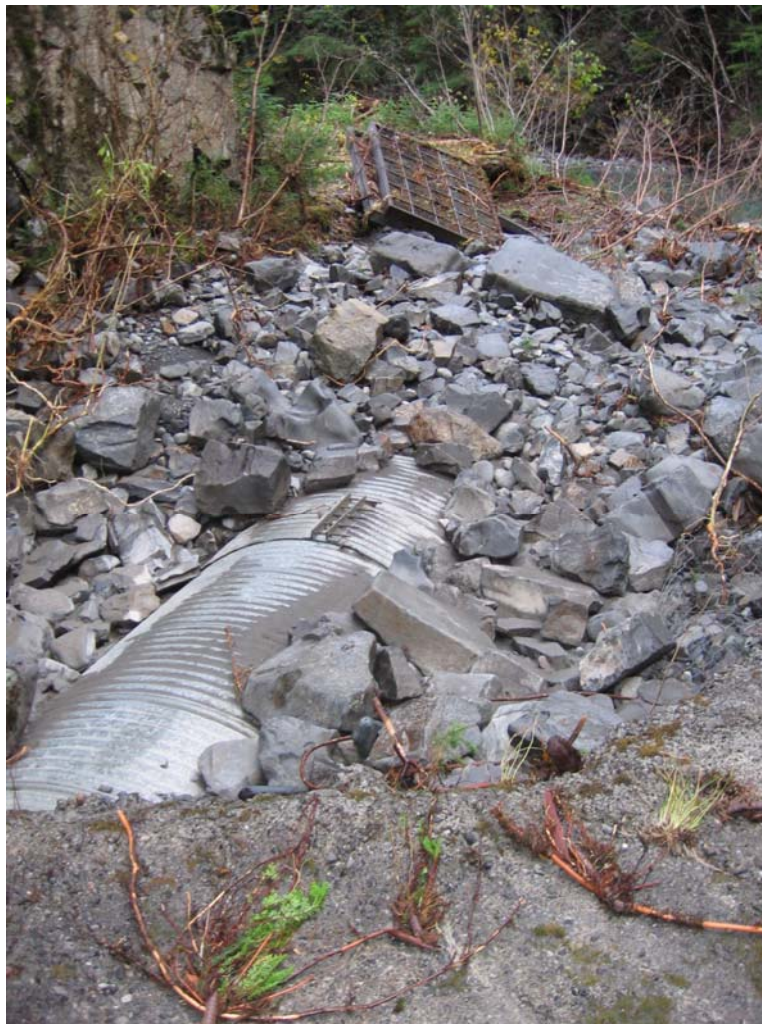
**Photograph No. 5**

Photo 5 shows the existing cmp pipe upstream from the building. Most of the gravel over this pipe has been scoured and a concrete collar near the end of the pipe prevented a complete failure. Additional armor rock and fill is needed to properly protect the pipe from future events as indicated for the building.

Intake at power plant has had substantial gravel scoured from cmp pipe.

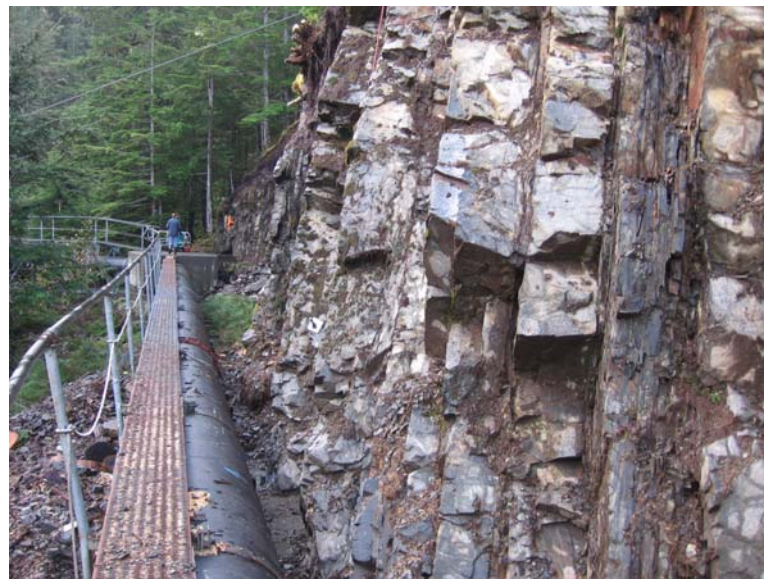
**Photograph No. 6**

There is one area that has been identified as stable but should be monitored carefully. The rock stabilization conducted prior to the bridge (approximately midway) contains one section with a rock bolt installed near the toe of a larger block. The current configuration is stable with this rock bolt. Additional bolting could not be conducted since all rod stock was used during the installation. Although considered stable future monitoring should be performed at each periodic inspection of the site to determine if additional scaling or bolting may be required at this area (area shown in right side of Photo 6).

Rock stabilization construction final inspection with Pacific Blasting was conducted as part of this trip. This area is just prior to the bridge. Cut timbers should be installed for added protection from future rock fall.

PND discussed with Danny Ackmann from CEC the need to re-install some of the cut-up logs on the section just prior to the bridge (right side of penstock in Photo 6). There is a substantial amount of cut-up timber that could be placed on the uphill portion adjacent to the penstock to provide additional protection from loose rock falling on the pipe.

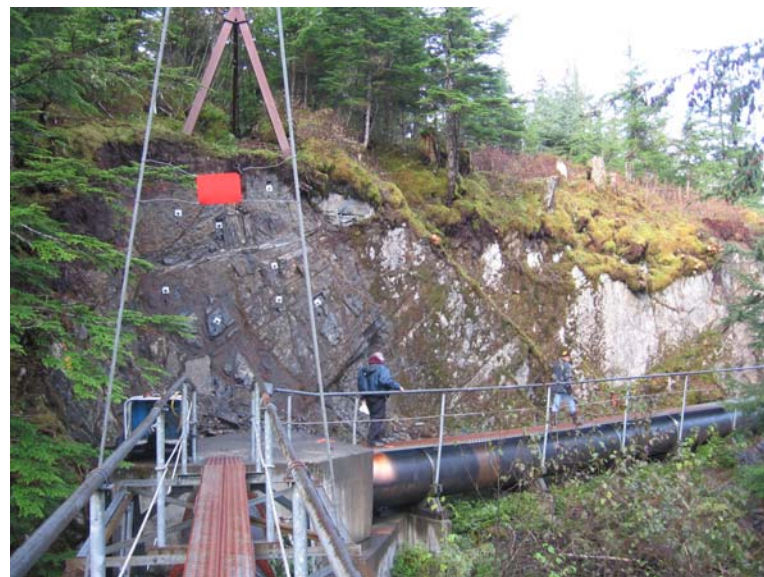
**Photograph No. 7**

Rock bolting conducted just prior to bridge.

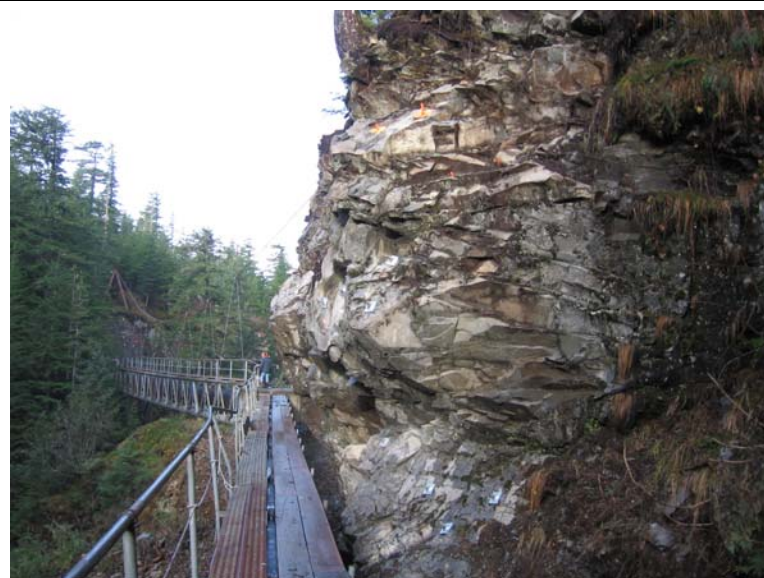
**Photograph No. 8**

Scaling and rock bolting completed upstream from bridge.

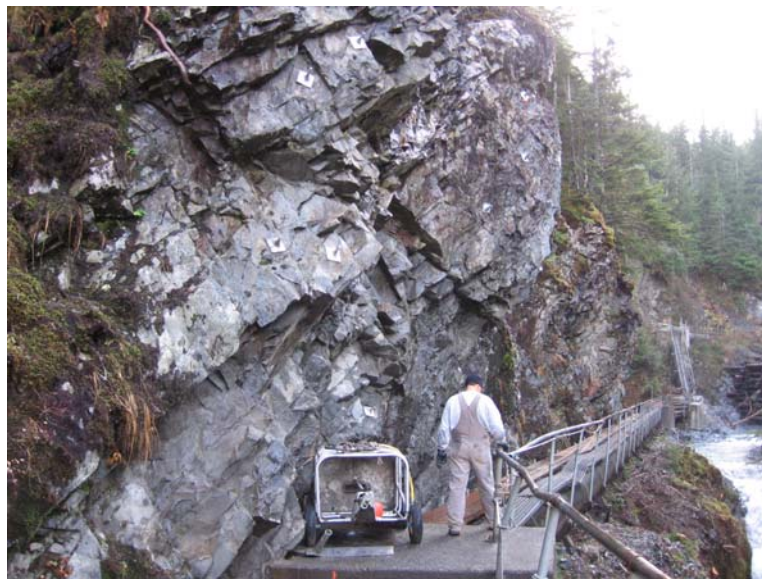
**Photograph No. 9**

Rock slope stabilization completed upstream from bridge.

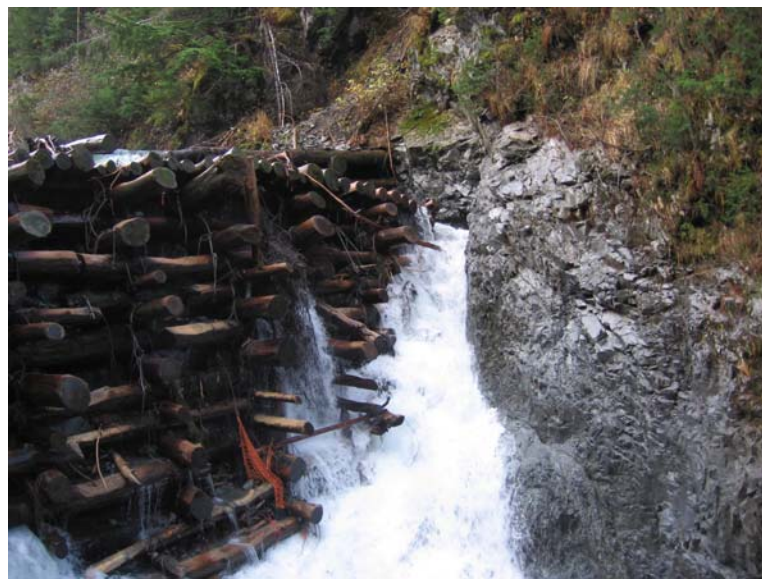
**Photograph No. 10**

The existing log crib dam did experience some damage on the left side of the dam but could not be assessed fully due to the high water level during our field trip. This should be assessed further after water flows are somewhat lower.

Left abutment of log crib dam has lost some timbers.

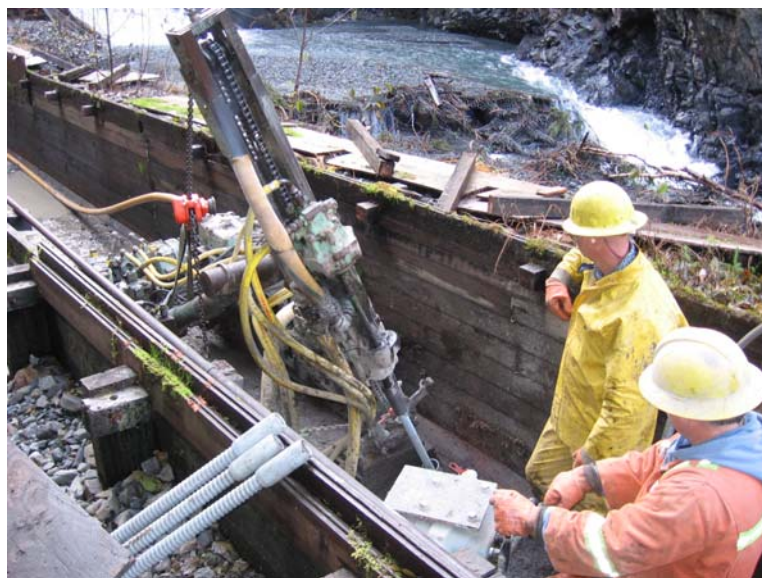
**Photograph No. 11**

Micropile installations were being constructed by Bell Pacific, a division of Pacific Blasting from Burnaby, British Columbia. This work was started less than one week ago and significant progress was being made. Photos 11 and 12 depict this work. The majority of micropiles appear to be installed from 25 to 40 feet. CEC is monitoring the depths on a daily basis and will prepare as-built plan of each pile bent as work progresses. Installations appeared to be performed according to the plans and specifications with the exception of the requirement to minimize the number of wood flume brace removals. PND had originally indicated on the design documents that only enough top braces should be removed to allow movement of the micropile drill equipment and as equipment moved up the wood flume these braces should be replaced during construction for safety reasons. We discussed this with CEC personnel and Bell Pacific was planning to reinstall these braces and change construction practices.

Micropile installations currently being constructed to replace wood flume.

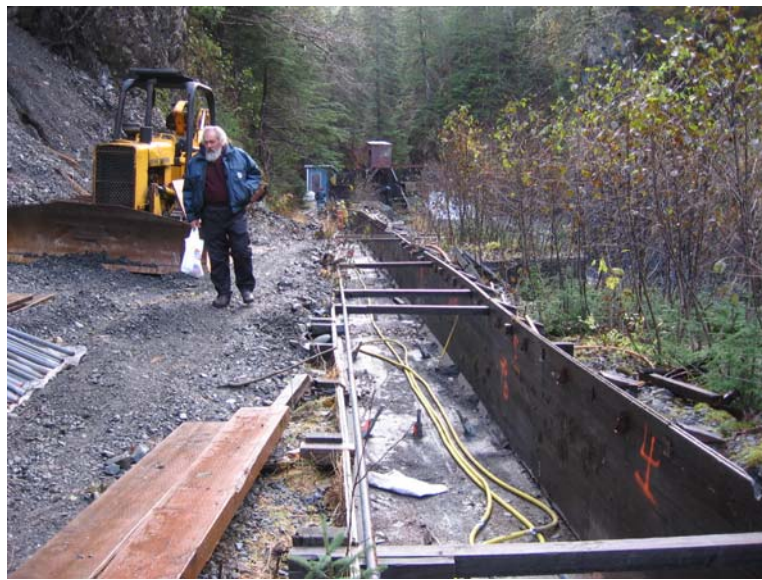
Photograph No. 12

View along wood flume with micropile supports partially completed.

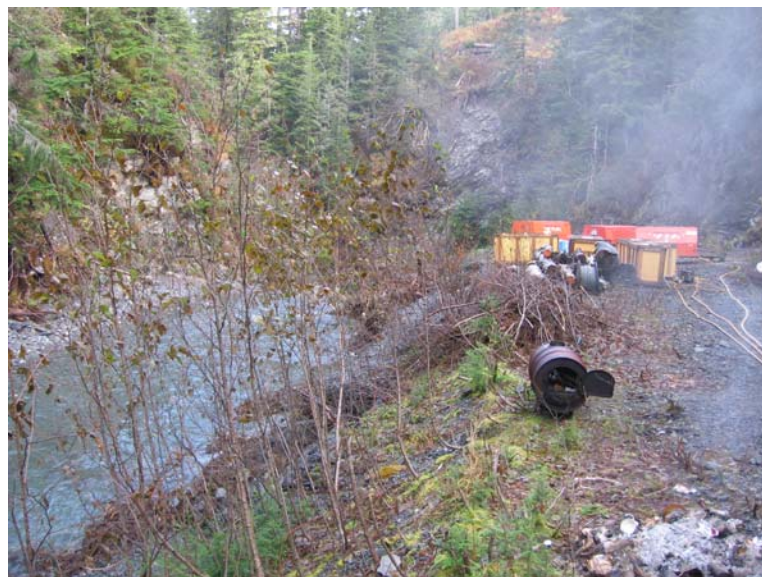
Photograph No. 13

View of right stream bank above log crib dam. Some additional scour has occurred.

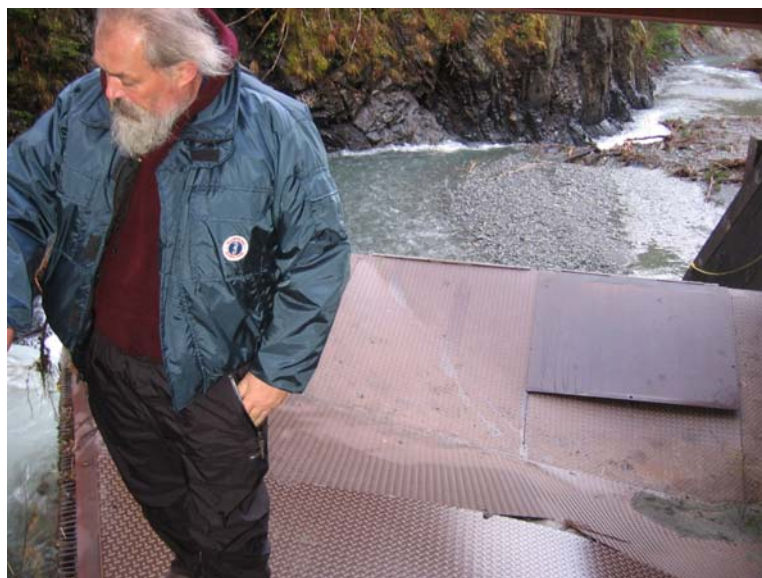
Photograph No. 14

The spillway and instake structure have been damaged to a point that in our opinion it is beyond repair. We would recommend that damaged steel be cut up and removed from the stream. This can be stockpiled on shore for later removal or if done in time the helicopter that will be used to demobilize Bell Pacific's equipment in the next week or two could be used to remove the materials.

View of damage to intake screen metal top.

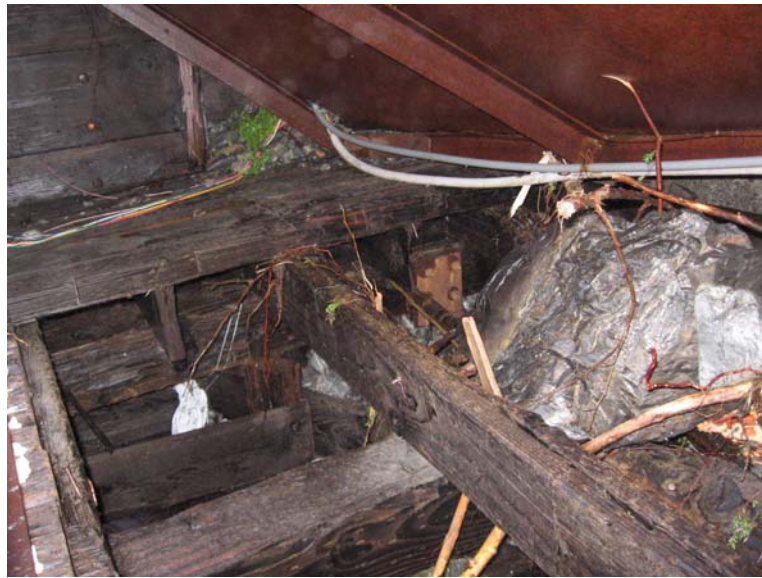
Photograph No. 15

View of inside of intake.  
Boulder damaged supports for  
metal cover and damaged  
timber supports.

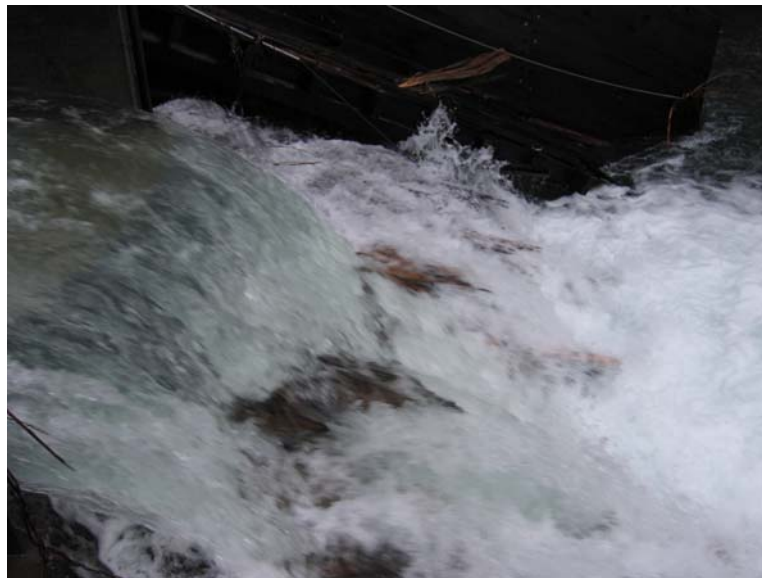
Photograph No. 16

Wooden spillway has  
sustained significant damage  
from recent event.

We would also recommend removing as much of the timber spillway structure as safely feasible at this time.

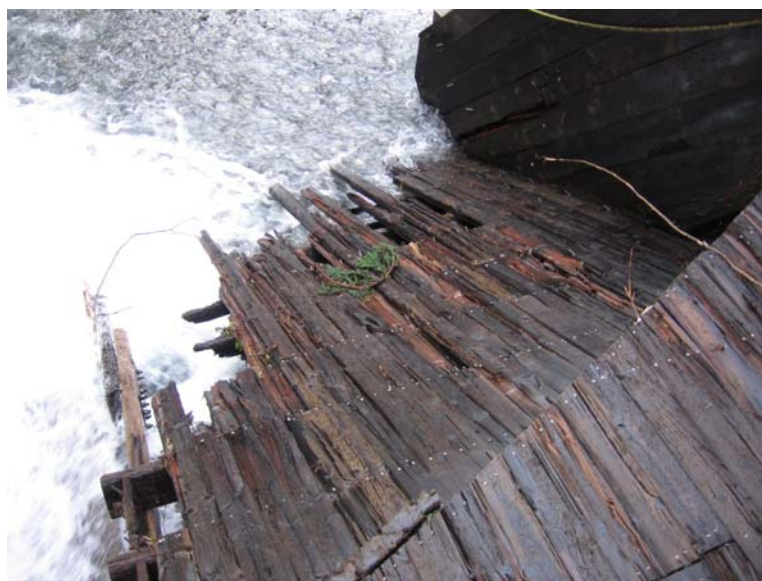
Photograph No. 17

View of right side of timber  
spillway. Note damage to  
underlying timber supports  
and top deck.
